# Deep Drilling Necessary to Test Dam's Integrity

## **A CSDA Member Is Called Upon After Severe Flooding Threatens to Collapse the Structure**

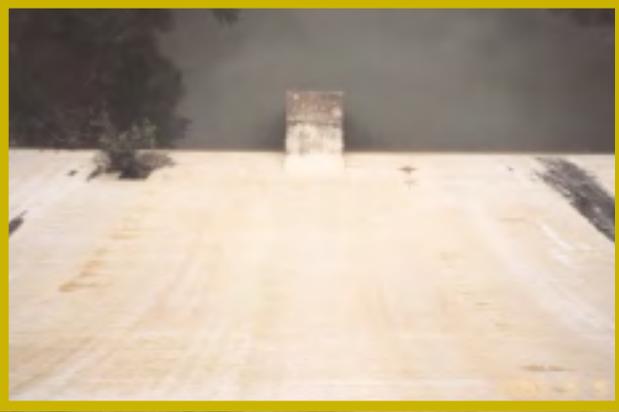
**Above:** The Summer 2002 flooding was the worst anyone could remember in San Antonio, Texas. **Inset photo:** It was believed more flooding could cause the dam to give way.

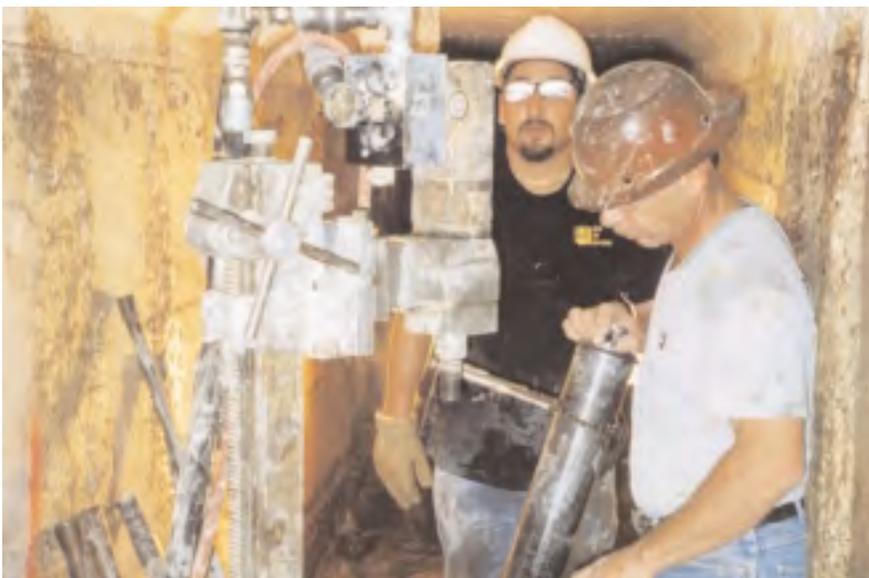
Five holes, 4 inches in diameter were drilled through the bottom of the dam and then drilled 8 feet into the bedrock beneath the dam, giving URS a total hole depth of 16 feet. The biggest challenge operators faced was working in a confined space — drilling deep holes with no headroom was time consuming and tedious. Extracting the cores also proved to be a slow process given the space constraints and lack of headroom. Once the holes were complete, URS began setting the piezometers in the holes.

**Above: The biggest constraint on this job was space—or lack thereof. Holes were core drilled into the bottom of the dam so piezometers could be installed.**
